Manhole Inspection Summary

Manhole # S07YY1002MH

Insp Date: **9/13/06 10:22 AM**

Location Address: **5801 KEY AVE**

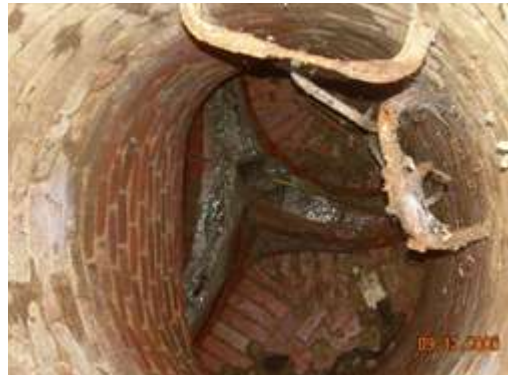
Top View

Corroded steps. Evidence of surcharge - Bench debris.

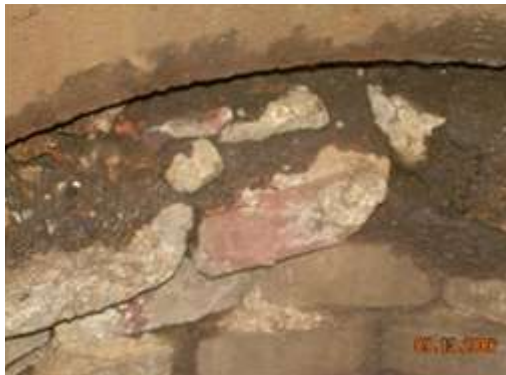
Defect

☒ **Leaks**

Condition: ☐ Sound ☐ Cracked ☐ Root Intrusion ☒ **Loose Brick** ☒ **Deteriorated**

Infiltration: ☐ None ☒ **Joint** ☐ Cracks ☒ **Mortar** ☐ Roots ☐ Wall

Frame leaks. Adjustment deterioration and infiltration.

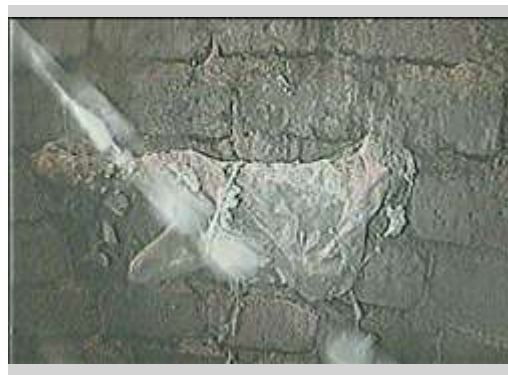
Defect

Condition: ☐ Sound ☐ Cracked ☐ Root Intrusion ☐ Loose Brick ☒ **Deteriorated**

Infiltration: ☐ None ☐ Joint ☐ Cracks ☒ **Mortar** ☐ Roots ☐ Wall

Evidence of surcharge. Barrel deterioration and infiltration.

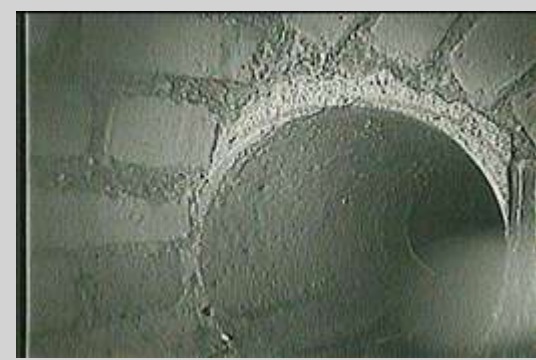
10 in. Circular Gravity Sewer Pipe Out @ 12 O'Clock

Pipe Material: **Clay** ☐ Pipe Lined

Invert Depth: **10.75** (ft.) Flow Characteristics: **Slow**

Infiltration: **None** Pipe Seal Cond: **Unknown**

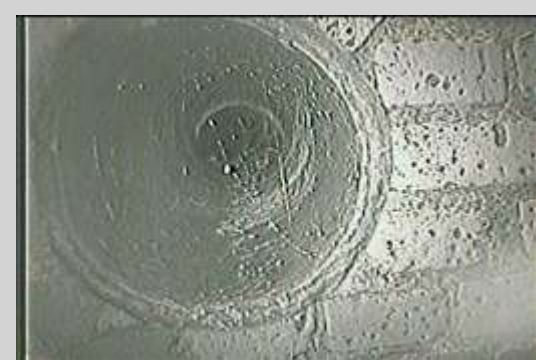
8 in. Circular Gravity Sewer Pipe In @ 3 O'Clock

Pipe Material: **Clay** ☐ Pipe Lined

Invert Depth: **7.78** (ft.) Flow Characteristics: **Slow**

Infiltration: **None** Pipe Seal Cond: **Unknown**

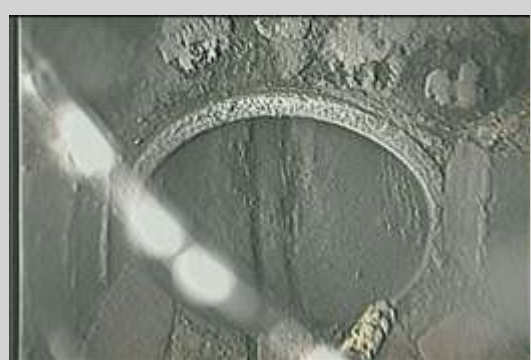
Drop In @ 3 O'Clock

Drop: **Outside** Rod and Bar

Inv Depth: **10.35** (ft.)

Drop Condition: **Open**

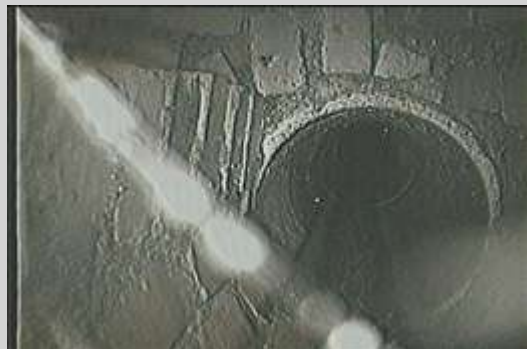
Pipe In @ 7 O'Clock

Pipe Material: **Clay**

Invert Depth: **10.68** (ft.) Flow Characteristics: **Slow**

Infiltration: **None**
